Agenda

Sacramento Suburban Water District/Del Paso Manor Water District 2x2 Ad Hoc Committee

Subject: Safety Condition Assessment

DEL PASO MANOR WATER DISTRICT**Date of Visit: March 11, 2020****Advisor: Thor Benzing****RECOMMENDATIONS**

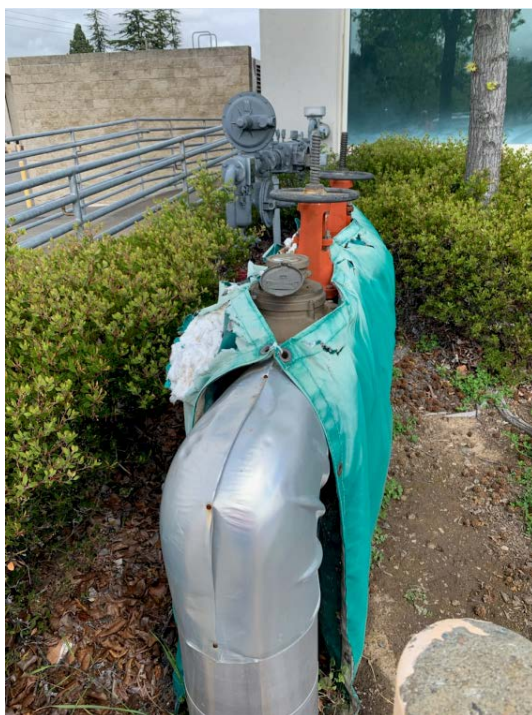
3601 Kings Way – 6 inch meter assembly

- Meter Specification - 6-inch Sensus compound meter that is obsolete and has not been supported by Sensus since 2011. Parts are not available to make repairs.

Meter on backflow preventer assembly

- Remove meter from the backflow assembly and install the meter assembly as per SSWD Standard Detail No. 18 (Attachment 2), which is consistent with AWWA standards.
- Replace the current obsolete meter with an AMI compatible 6-inch compound meter.
- 6-inch meters are considered high revenue meters and should be tested annually to ensure an accurate revenue stream.

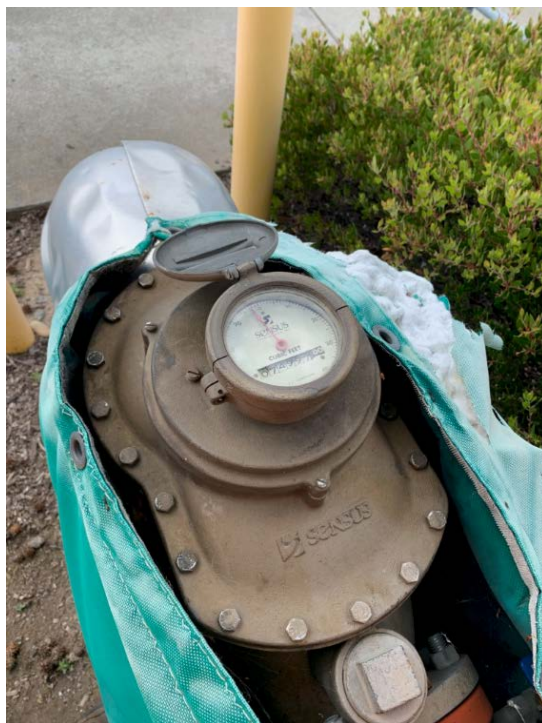
Obsolete 6 inch compound meter

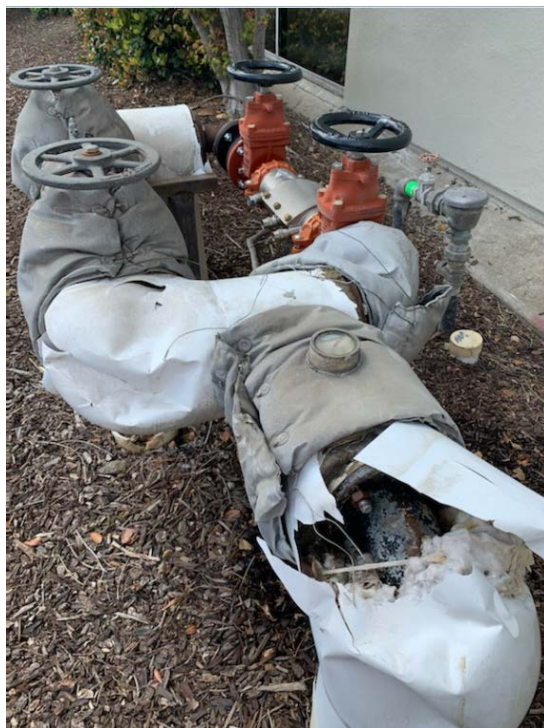
3542 Kings Way – 3-inch meter assembly

Meter on backflow preventer assembly

- Remove the meter from the backflow assembly and install the meter assembly as per SSWD Standard Detail No. 16 (Attachment 4), which is consistent with AWWA standards.
- Replace the current turbine meter with an AMI compatible 3-inch compound meter. 3-inch compound meters are accurate down to ½ gpm.
- Test the meter on a 3-5 year cycle depending on annual usage.

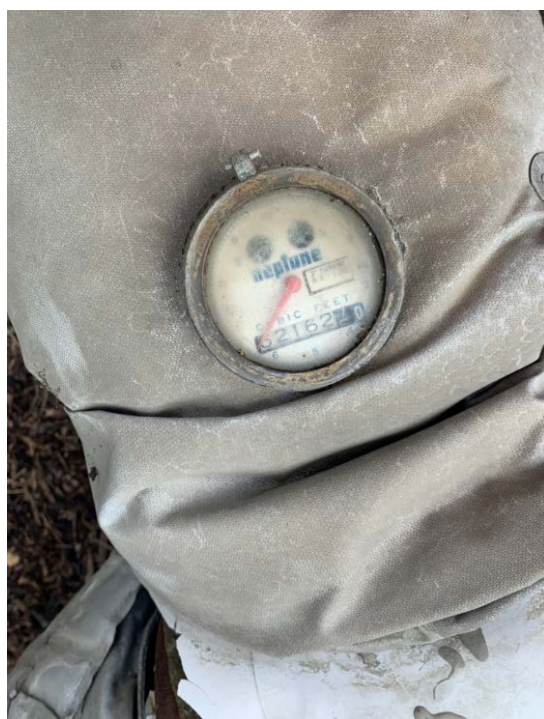
3-inch turbine meter

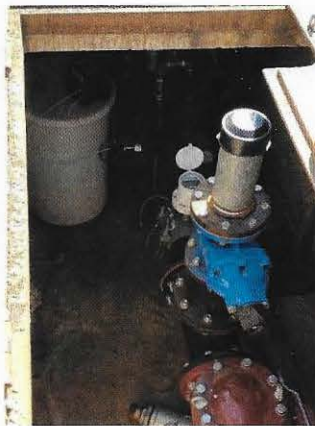
DEL PASO MANOR WATER DISTRICT**Date of Visit: March 11, 2020****Advisor: Thor Benzing****20-02****CHEMICAL HAZARD****Location:** Well #7

Issue: Sodium Hypochlorite is stored in the well with no ventilation. Any chlorine gas vapors released by the stored Sodium Hypochlorite will be trapped in the vault due to having a heavier relative vapor density. Besides the chlorine hazard, there is a risk of displacing the available oxygen in the space. Either or both can create an immediately dangerous to life or health (IDLH) condition within the space.

Option 2: Test the space and ventilate the space prior to any entry as prescribed in recommendation 20-01 "Option 2".

In addition, an emergency eyewash station is needed at this site due to staff exposure risk to Sodium Hypochlorite when filling.

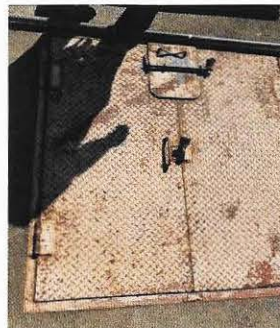
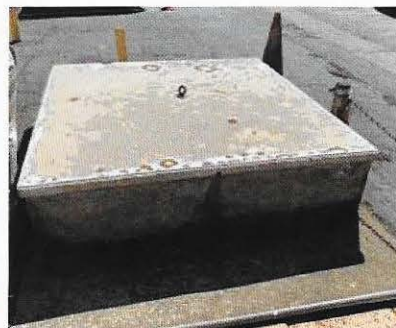
**Response:****20-03****SIGNAGE****Location:** Well #7

Issue: The permit-required confined space not correctly labeled.

Recommendation: Stenciled or place a sign on the vault lids per Cal/OSHA 8 CCR §5157(c)(2)

DANGER
PERMIT-REQUIRED CONFINED SPACE
DO NOT ENTER

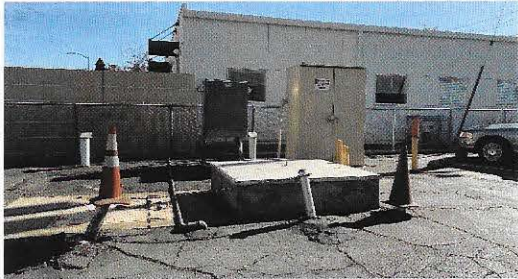
<u>20-04</u>	<u>SIGNAGE</u>
	<p>Location: Well #2, #3, #4, #5</p> <p>Issue: The permit-required confined space not properly labeled.</p> <p>Recommendation: Stenciled or place a sign on the hydropneumatic entrances per Cal/OSHA 8 CCR §5157(c)(2)</p> <p style="text-align: center;">DANGER PERMIT-REQUIRED CONFINED SPACE DO NOT ENTER</p> <p>Response:</p>
<u>20-05</u>	<u>PHYSICAL HAZARD</u>
	<p>Location: Well #7</p> <p>Issue: A few of the bollards around the well have been damaged by vehicles coming into contact with them. This damage has compromised the protection the bollards provide to the site and personnel.</p> <p>Recommendation: The District has placed cones on top of some of the bollards. However, this does not prevent future impacts or address the damage to the existing bollards. Recommend replacing the bollards and placing high visibility extensions over the new bollards.</p>

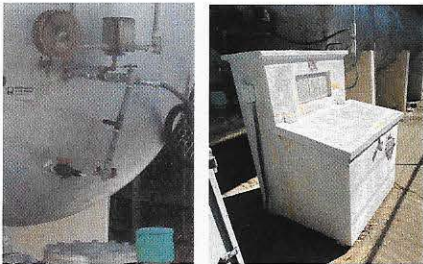
<u>20-06</u>	<u>SAFETY EQUIPMENT</u>
	<p>Location: Well #4</p> <p>Issue: The location and function of the eyewash station do not meet Cal/OSHA emergency eyewash and shower equipment standards or the requirements outlined in ANSI Z358.1. The current eyewash station requires two actions to activate. Additionally, it is on the far side of where the sodium hypochlorite is stored and used.</p> <p>Recommendation: Remove the existing eyewash station. Plum a new eyewash station or mount a portable eyewash station nearby the point of operation where the risk of chemical exposure has been identified.</p>

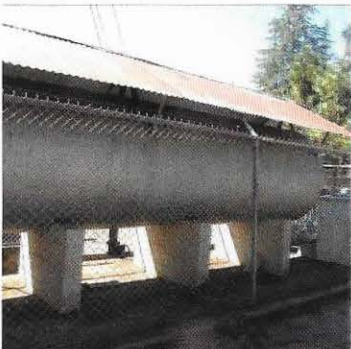
20-07	<u>HYDROPNEUMATIC TANKS</u>
	<p>Location: Wells #2, #3, #4, and #5</p> <p>Issue: In 2014, the District received a hydropneumatic tank (non-jurisdictional) inspections from Arise, as indicated in the attached reports. The purpose of these inspections was to determine the operability of the tanks and to recommend actions that would preclude catastrophic failure.</p> <p>Included in the 2014 ACWA/JPIA Risk Assessment Report dated August 1, 2014, was recommendation 14-01. This recommendation was trying to ascertain what actions the District would be taken to address the recommendations provided by Arise 2014 reports.</p> <p>JPIA received a response to the 14-01 recommendation on September 3, 2014. In this response, Debra Sedwick, District General Manager at the time, stated the "Action not feasible or practical at this time. Our Master Plan calls for replacement or elimination of tanks as we replace wells. Cost is prohibitive now."</p> <p>During the 2019 & 2020 JPIA Risk Advisor visits, none of the following recommended actions had taken place.</p> <p>Recommendation: Please provide a timeline for addressing these recommendations or removing the hydropneumatic tanks from service.</p> <p>Corrective actions should consider the following best practices:</p> <ul style="list-style-type: none"> • A pressure relief valve (PRV) should be installed that relieves at or below the tank's maximum designed operating pressure. PRVs should be tested annually and replaced every five years. If the PRV is installed with an isolation valve, lockout/tagout procedures should be used to keep the valve locked in the open position for normal tank operations. • Tanks without an ASME manufacturer data plate should be structurally evaluated by a registered engineer, to determine the maximum operating pressure and measuring the wall thickness of the tank, if it is to remain in-service. • The minimum allowable head and shell thickness indicators on ASME tanks must be compared to the thickness readings provided by the Arise inspector. Operations for tanks with thickness readings less than the minimums should be discontinued or modified as determined by an ASME-qualified engineer. <div style="display: flex; justify-content: space-around; align-items: flex-end;"> <div style="text-align: center;">

<p><i>Picture of Well #3 in 2015</i></p> </div> <div style="text-align: center;">

1	20-07	2, 3, 4, 5	Hydropneumatic Tanks	In 2014, the DPMWD received a hydropneumatic tank inspection from Arise. The purpose of the inspection was to determine the operability of the tanks and to recommend actions that would preclude catastrophic failure. In 2014, JPIA recommended actions for the DPMWD to take to address the findings of the Arise inspection. During the 2019 and 2020 JPIA Risk Assessments, none of the recommendations had taken place.	(1) A pressure relief valve should be installed that relieves at or below the tank's maximum designed operating pressure. (2) Tanks without an ASME manufacturer data plate should be evaluated by a registered engineer to determine the maximum operating pressure and measuring the wall thickness of the tank, if it is to remain in-service. (None of the tanks have data plates.) (3) The minimum allowable head and shell thickness indicators on ASME tanks must be compared to the thickness readings provided by the Arise inspector. Operations for tanks with thickness readings less than the minimums should be discontinued or modified as determined by an ASME-qualified engineer.	DPMWD is coordinating with JPIA & SSWD

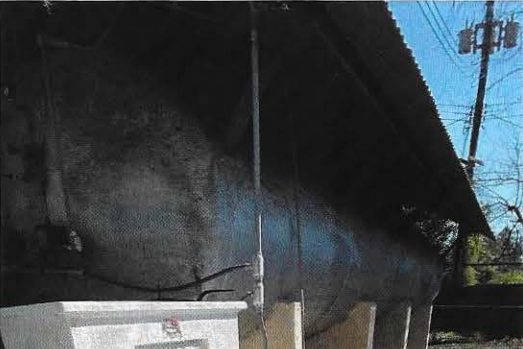
<p><i>Picture of Well #4 in 2020</i></p> </div> </div>

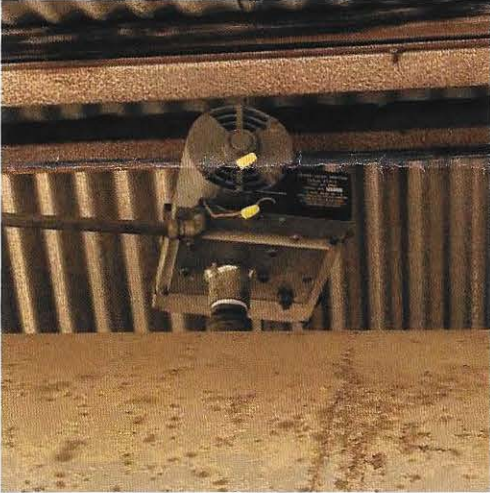
<u>20-08</u>	<u>ELECTRICAL HAZARD</u>
	<p>Location: Well #4</p> <p>Issue: Electrical wires connected to the compressor on top of the hydropneumatic tank are exposed.</p> <p>Recommendation: Electrical connections need to be inside an appropriately rated junction box.</p>

2	20-08	4	Electrical Hazard	Electrical wires on compressor on top of hydropneumatic tank are exposed.	Install wiring into correct NEMA junction box.	DPMWD to coordinate with SSWD & hire a contractor if necessary
1	20-09	8	Control of Hazardous Energy	Pump controls electrical panel not correctly locked out and tagged out (LOTO) per Cal/OSHA requirements.	Install LOTO on panel as required.	DPMWD to coordinate with SSWD
1	20-10	8	Control of Hazardous Energy	Gate valve not locked/tagged out to physically prevent water from this well entering the distribution system.	Install chain and LOTO handle of gate valve. SSWD staff secured the valve with chain and lock to physically isolate the well from the distribution system.	DPMWD to coordinate with SSWD
2	20-11	8	Permit	Propane tank: Cal/OSHA Permit to Operate has expired.	JPIA will coordinate a representative from Hartford to meet with SSWD staff and conduct the required inspection. Following, Hartford will file the appropriate paperwork with the state to issue a new permit.	DPMWD will coordinate with SSWD & JPIA

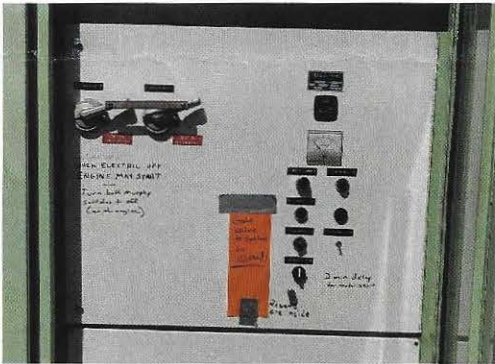
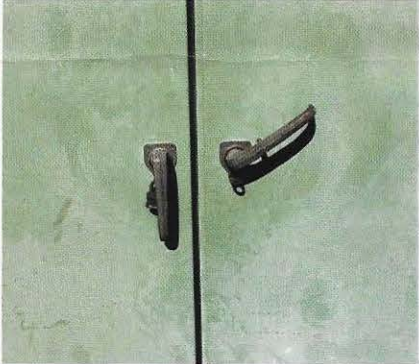
Response:
<u>20-09</u>	<u>CONTROL OF HAZARDOUS ENERGY</u>
	<p>Location: Well #8</p> <p>Issue: Pump controls not correctly locked out and tagged out (LOTO).</p> <p>Recommended Solution(s): Ensure the lock on the pump control panel is a unique lock and place a tag with this lock explaining who placed the lock, contact information, and either expected completion date of the work or date the LOTO was applied. (See attached LOTO guidance)</p>

<p><i>Sign inside cabinet</i></p>

<p><i>Please note, the cabinet door on the right was locked prior to this picture being take.</i></p>
	Response:

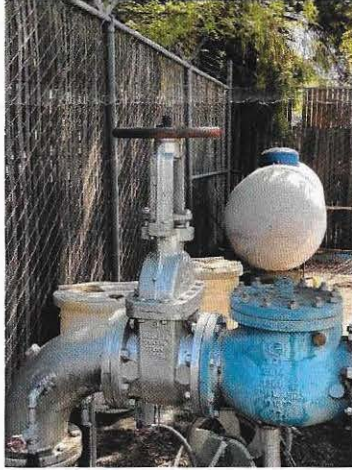
20-10	<u>CONTROL OF HAZARDOUS ENERGY</u>
	<p>Location: Well #8</p> <p>Issue: The gate valve is not locked out or correctly tagged out.</p> <p>Recommended Solution(s): Use an appropriate lockout procedure, device (i.e., valve cover or chain), unique identifiable lock, and appropriate tag to lockout the valve. This will prevent the unintended opening of the valve, while service and testing are being performed.</p>

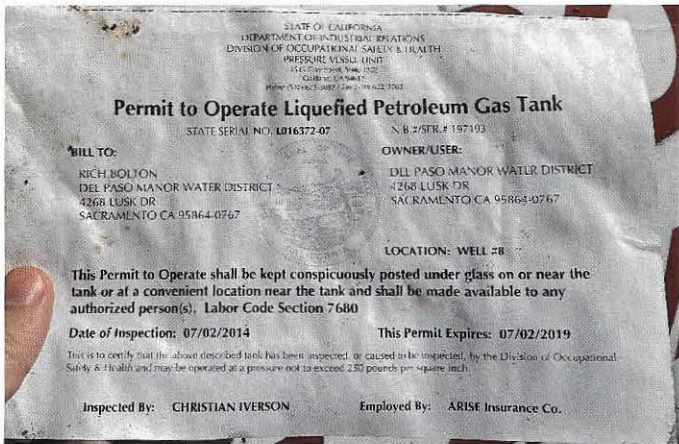
<p>Response:</p>
20-11	<u>PERMIT</u>
	<p>Location: Well #8</p> <p>Issue: Liquid Propane Tank: Cal/OSHA permit expired.</p> <p>Recommended Solution(s): JPIA will coordinate a represented from Hartford to meet with a District staff and conduct the required inspection. Afterword, Hartford will file the appropriate paperwork with the state to issue a new permit.</p>

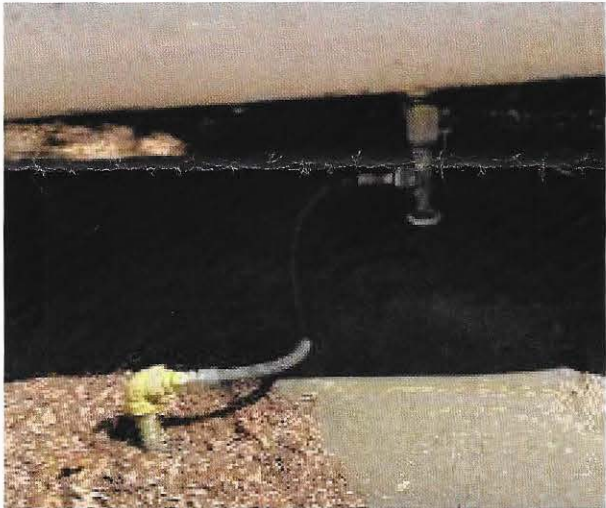
<u>20-12</u>	<p data-bbox="256 289 509 317"><u>PHYSICAL HAZARD</u></p> <p data-bbox="256 323 472 350">Location: Well #8</p> <p data-bbox="256 354 1430 382">Issue: Liquid Propane Tank: flexible hose connecting the tank to the hard-line is fraying and can fail.</p> <p data-bbox="256 386 1263 413">Recommended Solution(s): Replace the line with an appropriately rated flexible line.</p> <div data-bbox="555 443 1156 947">

2	20-12	8	Physical Hazard	Propane tank: Flexible hose connecting the tank to the hard-line is fraying and can fail.	Replace the line with an appropriately rated flexible line.	DPMWD to coordinate with SSWD
3	20-13	8	Signage	Propane tank does not have NFPA hazard diamond signage in place.	Install NFPA diamond sign on the tank with numbers - HEALTH = 2; FLAMMABILITY = 4; REACTIVITY = 0	Signage on order and will install once received

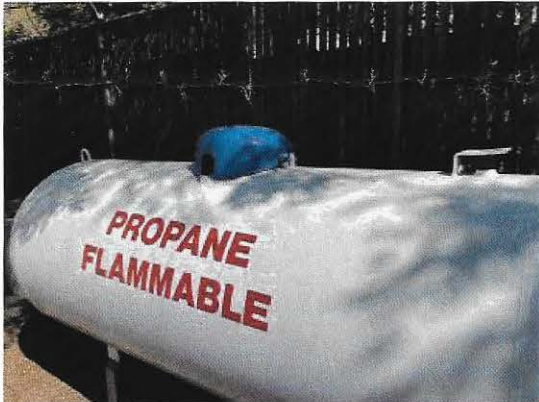
</div> <p data-bbox="256 982 391 1010">Response:</p>
<u>20-13</u>	<p data-bbox="256 1108 380 1136"><u>SIGNAGE</u></p> <p data-bbox="256 1140 472 1167">Location: Well #8</p> <p data-bbox="256 1171 927 1199">Issue: The liquid propane tank is missing safety signage.</p> <p data-bbox="256 1203 1430 1262">Recommended Solution(s): Its recommended to add an NFPA 704 (NFPA diamond) signs with the appropriate rating numbers. Health = 2, Flammability = 4, and Reactivity = 0</p> <div data-bbox="587 1287 1123 1686">

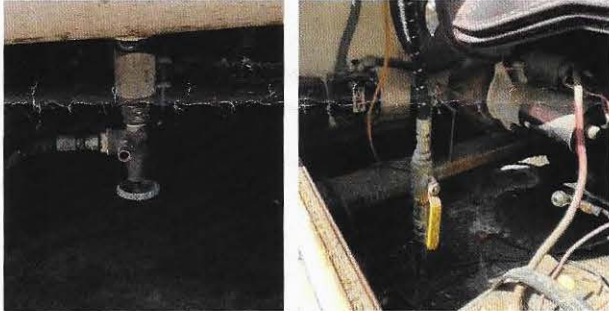
20-14	PHYSICAL HAZARD
	<p>Location: Well #8</p> <p>Issue: Currently, there are two shut off valves between the liquid propane tank and the motor. One located under the tank and the other within the emergency generator housing. However, there is no automatic shut off valve that can be triggered if there is a leak, and no staff is present.</p> <p>Recommended Solution(s): Install a leak alarm with an auto valve shut off.</p> <div data-bbox="558 506 1162 814">

2	20-14	8	Physical Hazard	No automatic shutoff valve on propane line between tank and generator.	Install a leak alarm with an automatic shutoff valve on propane line between tank and generator.	DPMWD will coordinate with SSWD
1	20-15	8	Slip, Trip, Fall	Chemical lines block access to eyewash and are trip hazard and do not have containment.	Relocate chemical lines up above conduit, allowing a safe path to eyewash and add containment tubing if there is a concern for a leak.	DPMWD will coordinate with SSWD

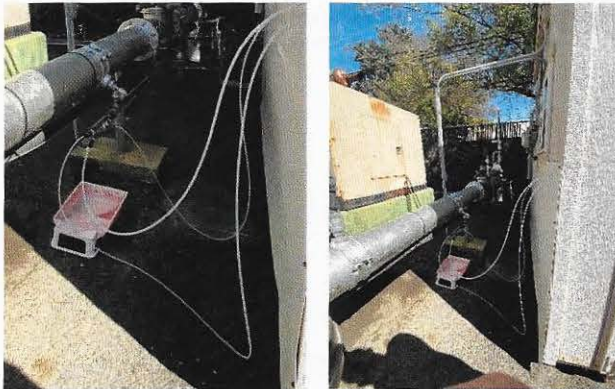
Response:
20-15	<p>SLIP, TRIP, FALL</p> <p>Location: Well #8</p> <p>Issue: Trip and access hazard due to chemical feed tubes.</p> <p>Recommended Solution(s):</p> <p><i>Option 1:</i> Extend the main feed line into the building and have the chlorine manifold connection inside the building. This will eliminate the fall hazard and contain any future spills within the building.</p> <p><i>Option 2:</i> Elevate the feed tubes, so they are no longer a trip hazard and restrict access to the eyewash station if an operator is on the east side of the tubes. This could be accomplished by rerouting the tubes up and over with the electrical conduit. Additionally, remove the paint roller pan as secondary containment. If there is a concern for a leak, place appropriately designed secondary containment around and/or below the feed tube connection.</p> <div data-bbox="552 1333 1162 1719">
