DEL PASO MANOR WATER DISTRICT AND SACRAMENTO SUBURBAN WATER DISTRICT

Subject: Condition of Del Paso Manor Water District Infrastructure

Subject: Safety Condition Assessment

Subject: Groundwater Facility Assessment

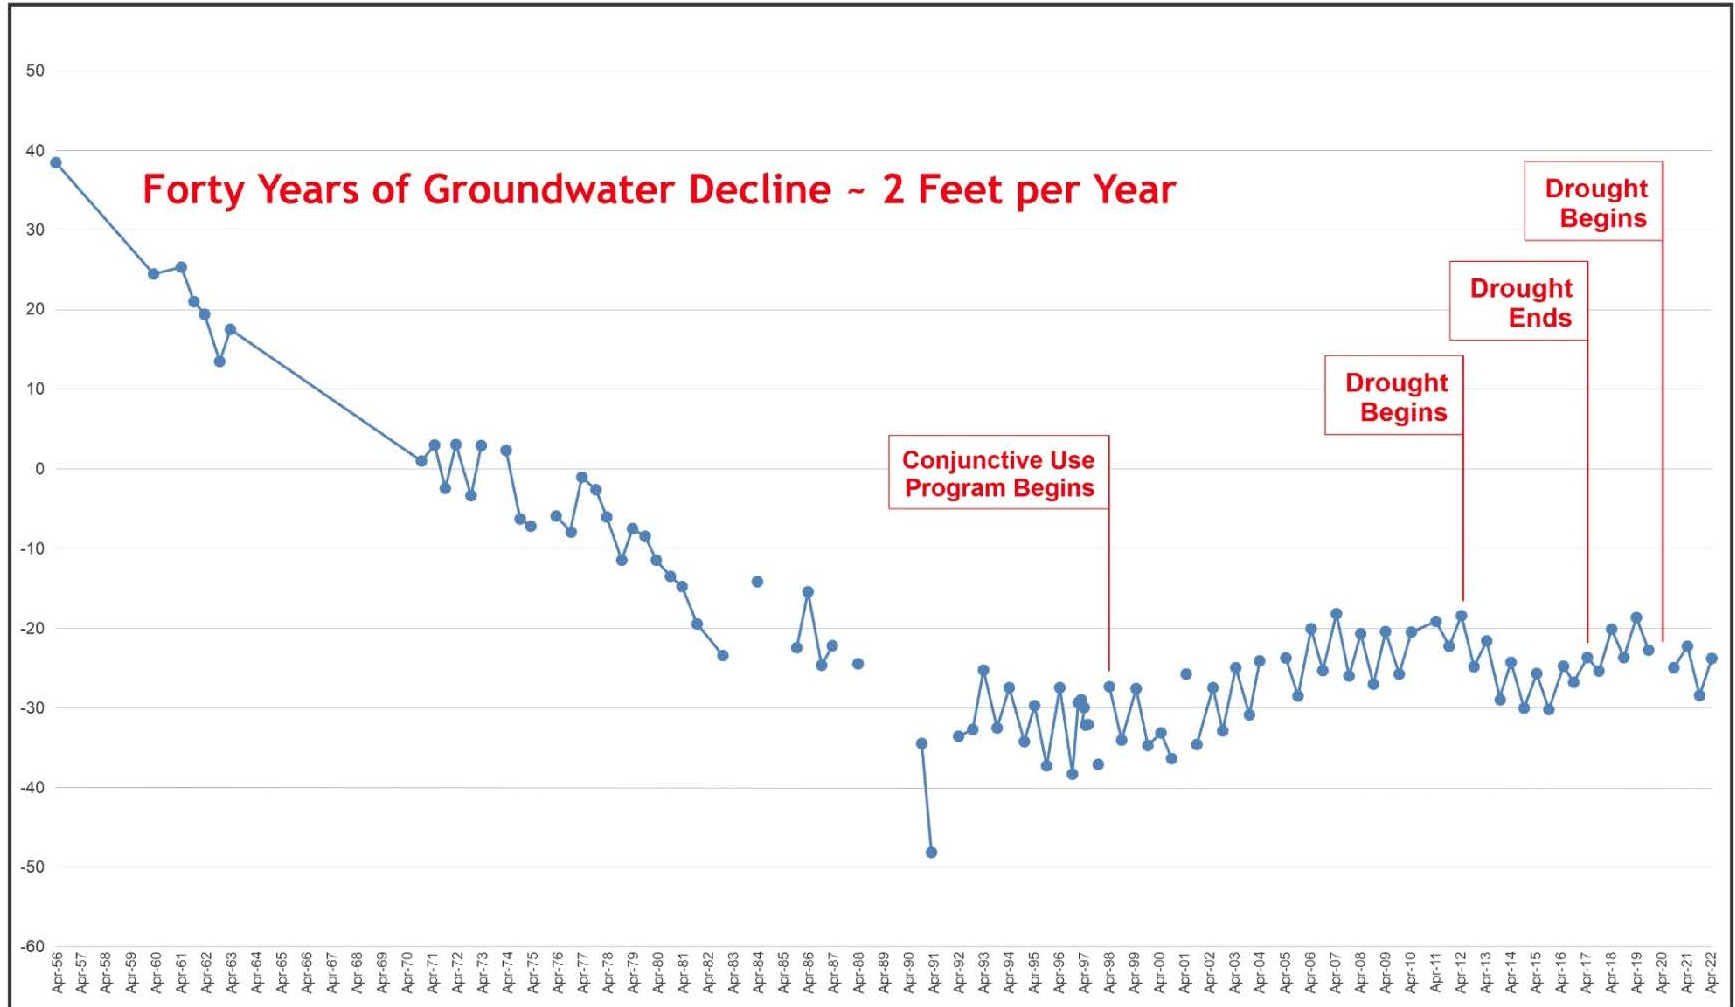
Groundwater Levels, Well 10N05E14Q002M Sacramento Valley (Sacramento County)

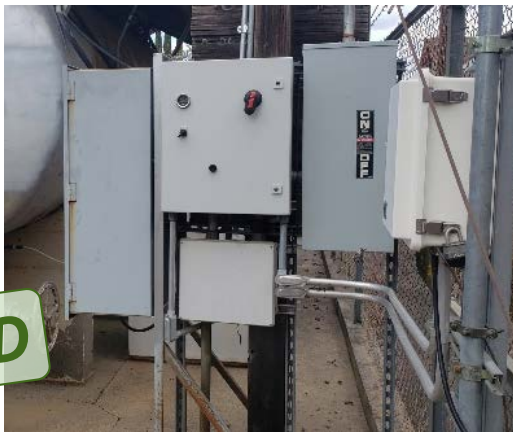
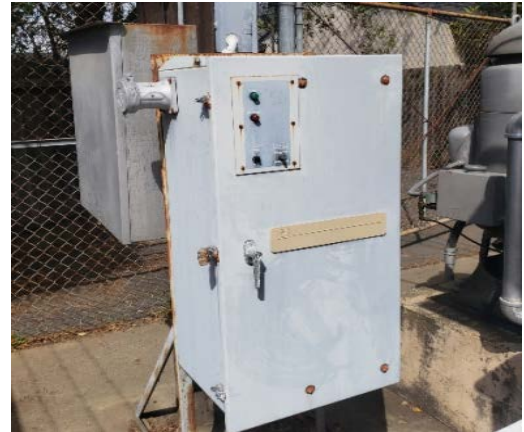
- There are no arc flash warning items, required by OSHA.

COMPLETED

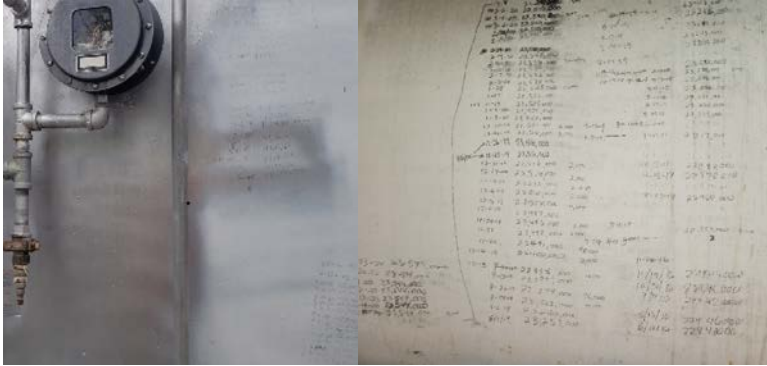
- There are few records of daily operations. On the left and right, there well production records for Well #2 and Well #4, respectively, written on the hydro pneumatic tanks.

COMPLETED

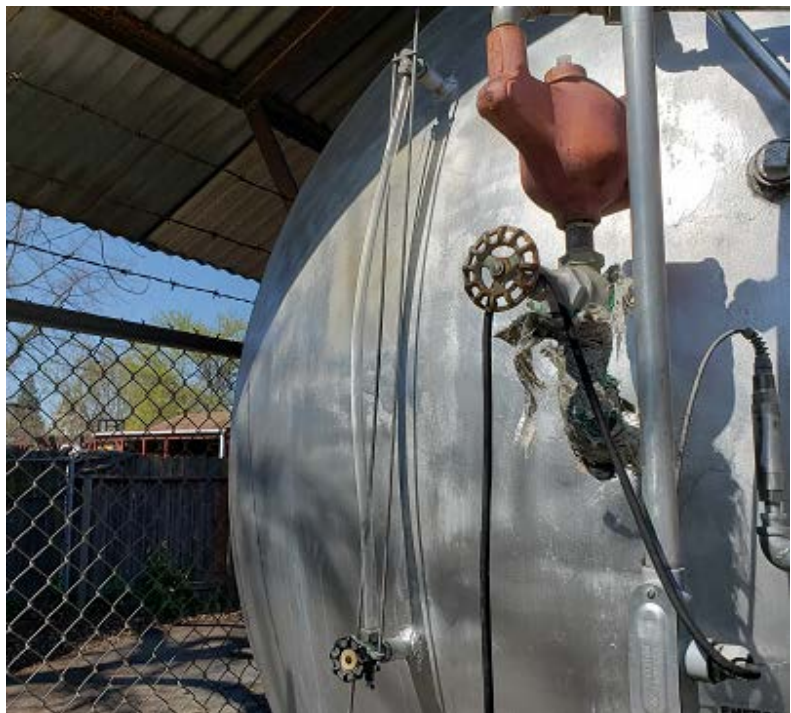
Well #2

- Tank is water logged at 90% water and site tube is warping from the sun. The air charge in the tank is necessary and is used to absorb system shock and reduce water hammer, which can cause leaks in distribution system.

COMPLETED

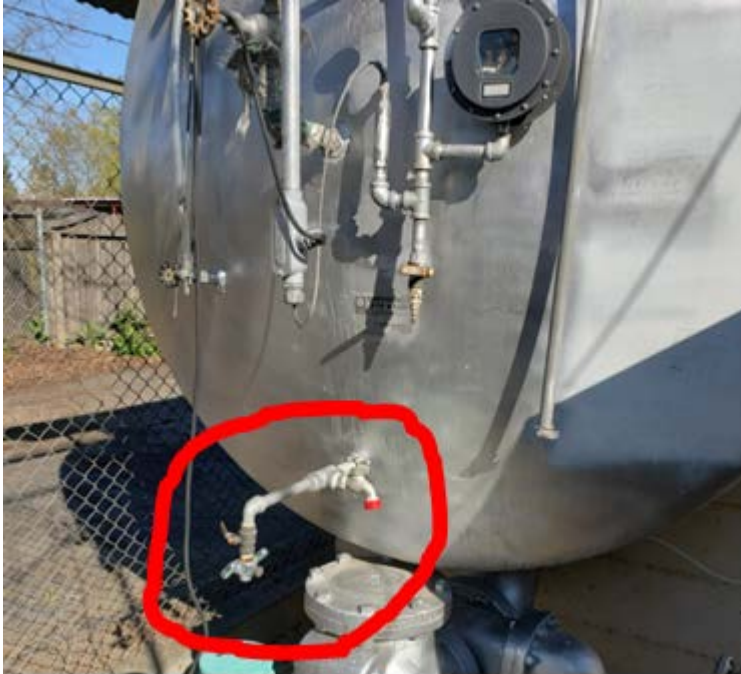
- The eyewash station position introduces potential hazards. There are tank appurtenances that could cause injury in the event an operator is in need of the eyewash station.

COMPLETED

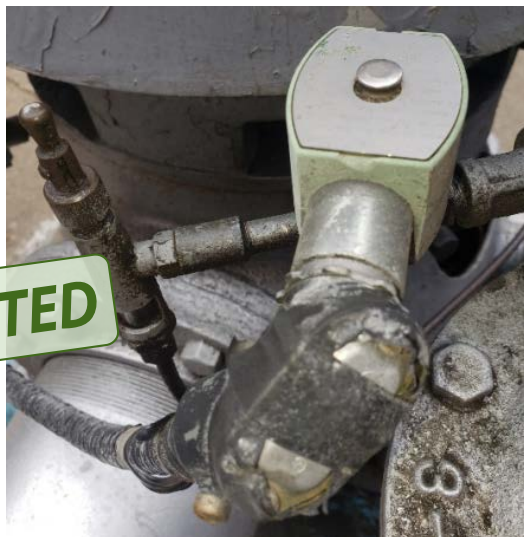
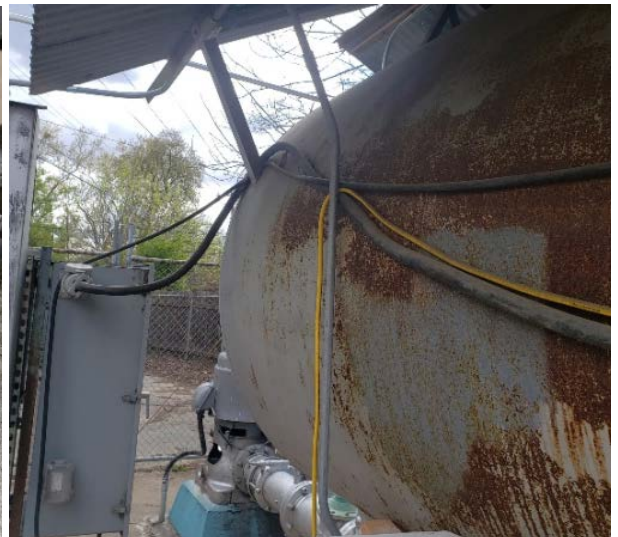
- Electrical conduit and equipment sealed with tape rather than the correct means. Electrical cables are strung across the tank and draped in the air presenting additional hazards.

COMPLETED

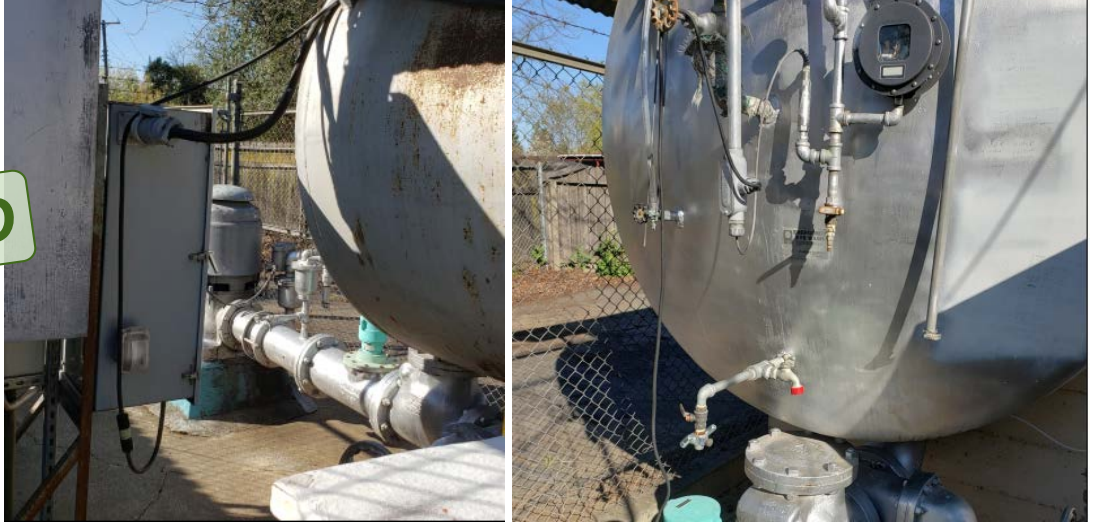
- The path of travel is restricted and also has overhead hazard. The second photo shows that there is no room to travel on other side of tank.

COMPLETED

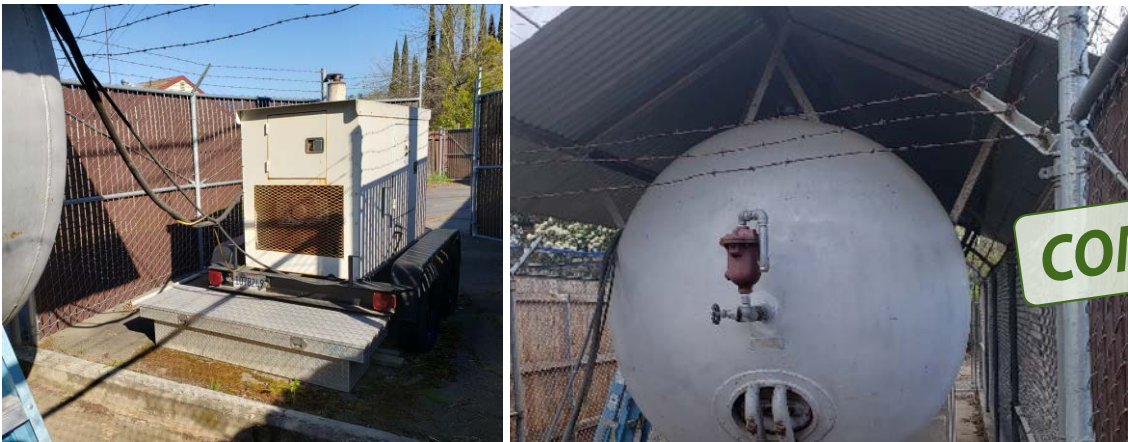
- An unpermitted generator and overhead hazards. Both pictures show cables hanging and barbwire through the middle of the facility.

COMPLETED

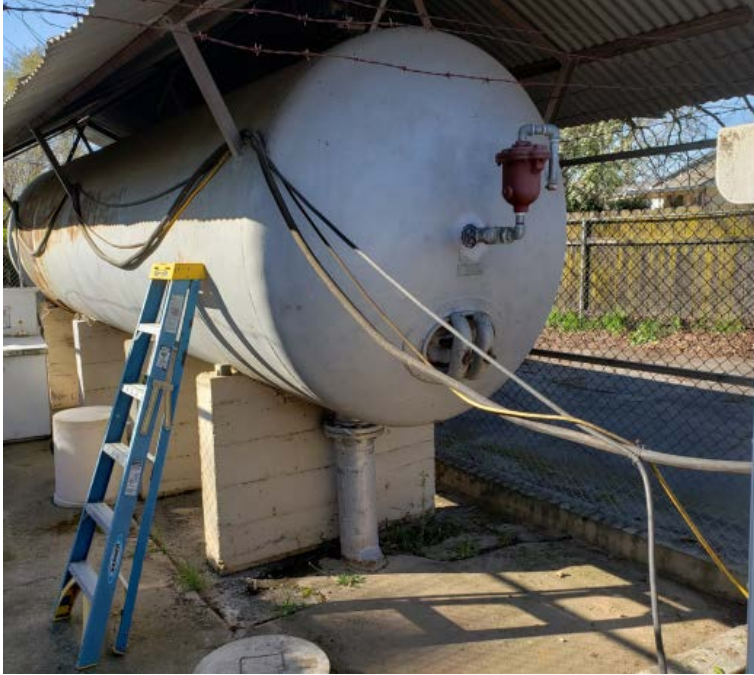
- Ladder is left at this site permanently so DPMWD staff can turn the air compressor on and off manually during the business day.

COMPLETED

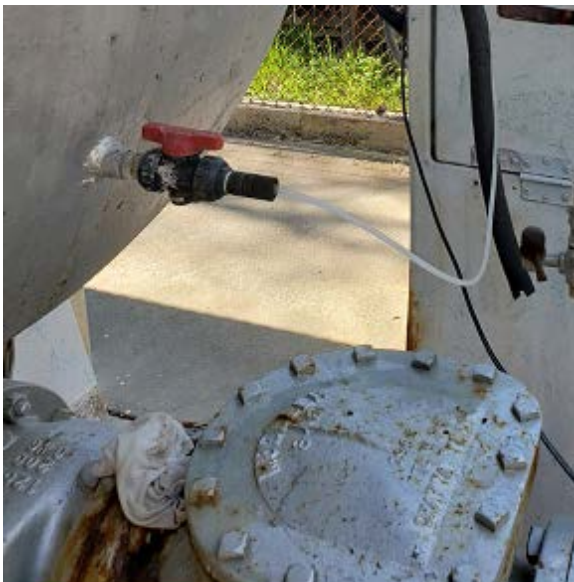
Well #4

- The chemical injection is located directly into the tank
 - The water in the tank could short circuit and not be adequately disinfected.
 - There is a leak on the injection system causing corrosion on the piping below. A rag was present to absorb drips.

COMPLETED

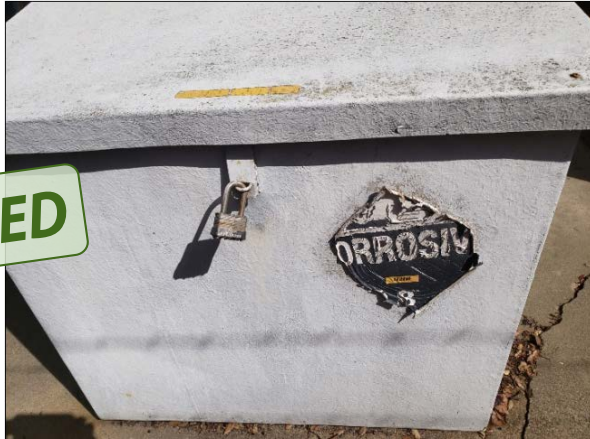
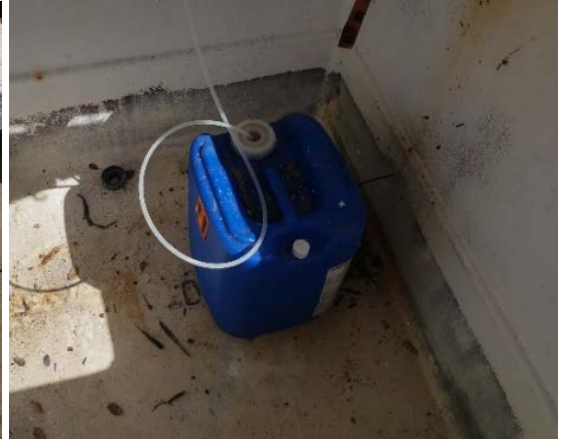
- There are no identifiers of what is contained within this locked container. This is where the liquid sodium hypochlorite is stored.

COMPLETED

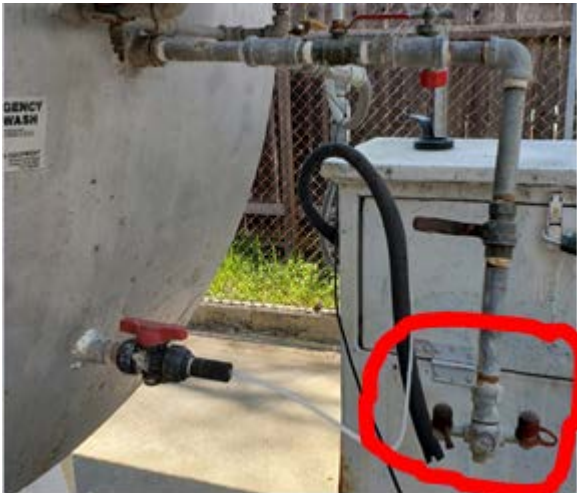
- The eyewash station is level with chemical injection, less than 12 inches away. The eyewash sign is small and on the tank. There are three valves on this eye wash station where one is left open, the second is closed but needs to be opened to flow water, and the third is a push button to make the water flow through the two nozzles. Cal-OSHA requires only one valve maximum to operate an eyewash station. The caps were sun damaged and shrunk requiring force to remove them.

COMPLETED

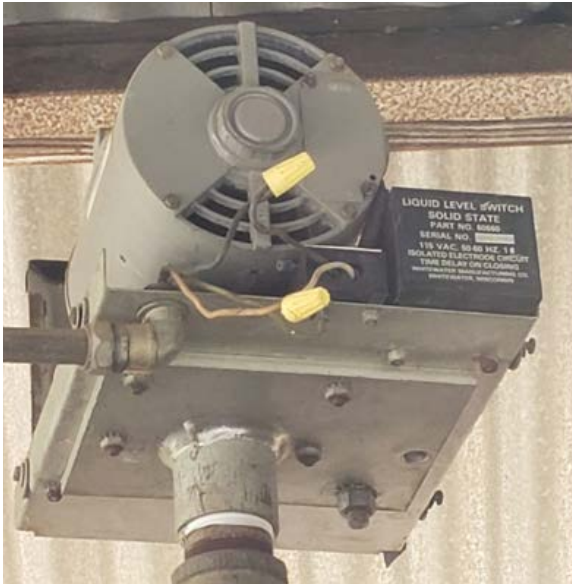
- Compressor wiring is left unsecured.

COMPLETED

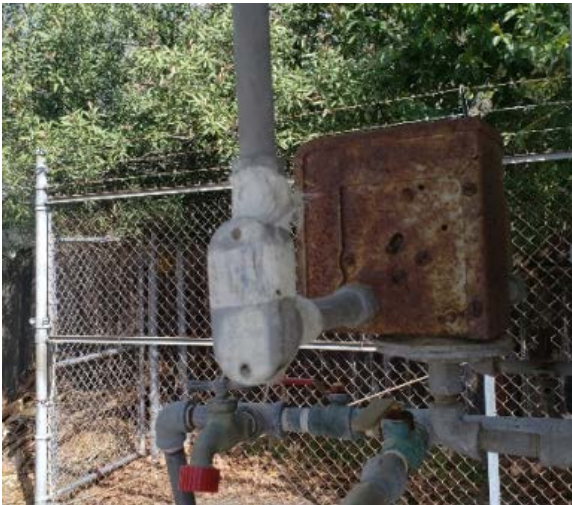
- Electrical LB junction box is secured with Duct Tape instead of the appropriate two screws holding the plate and gasket to seal against weather conditions.

COMPLETED

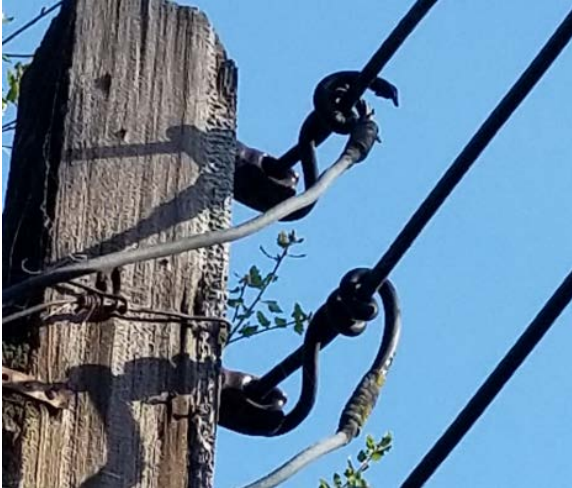
- Exposed utility power line is a safety hazard. SSWD staff requested that DPMWD staff notify SMUD. It has been corrected.

COMPLETED

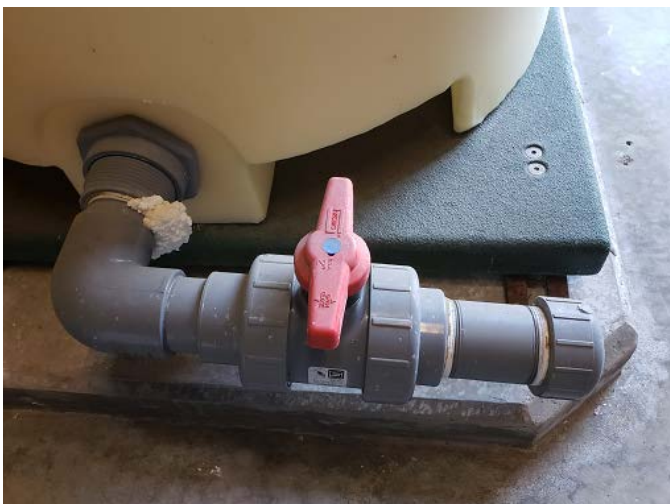
Well #6B

- The sodium hypochlorite double containment tank is compromised by placing drain valves at bottom of tank through both walls. Leaks have turned into build up on tank appurtenances. If the valve is broken off, the entire contents of the tank will empty, defeating the double containment requirement.

COMPLETED

**We completed leak repair on 6B NO LEAKS
Separately —decided to replace tank. Tank
purchased not yet installed cuz takes 2**

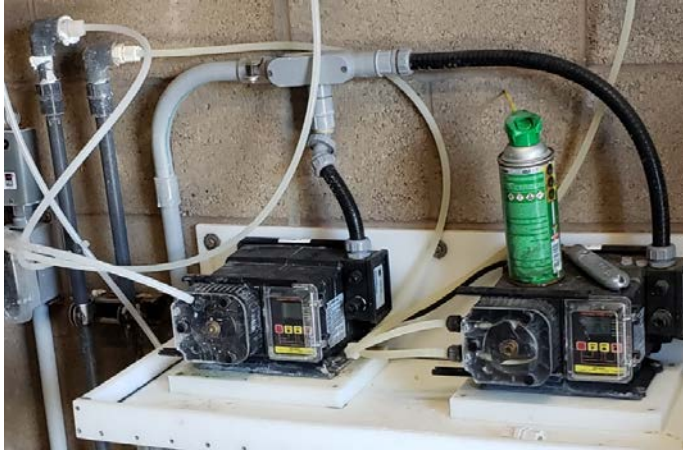
- There is no double containment on pressurized tubing and there are leaks where the tubing connects to the PVC piping. Lubricant spray was left sitting on top of chemical dosing pump.

COMPLETED

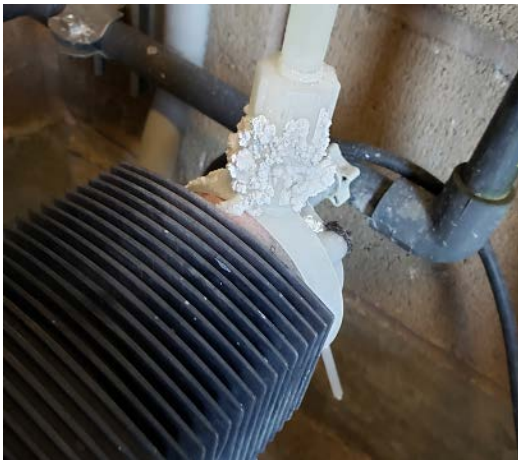
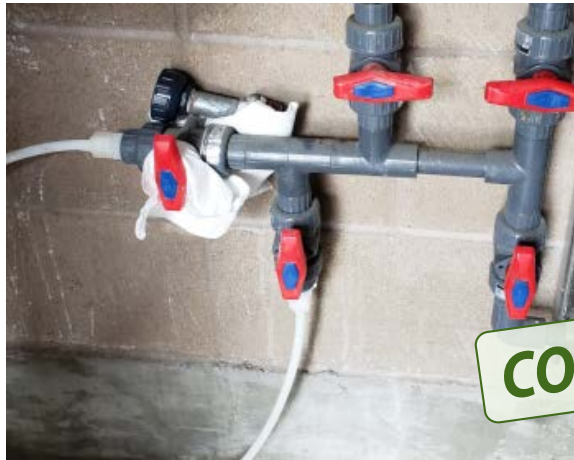
- Chemical pumps have leaks and build up. Rags are used to absorb chemical drips.

COMPLETED

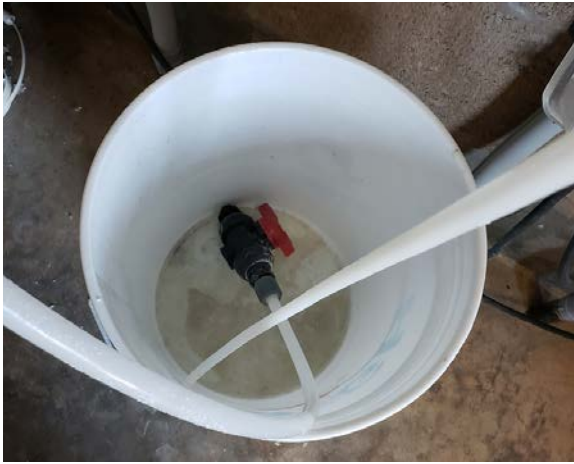
- Chemical degas pump discharges into an open bucket.

COMPLETED

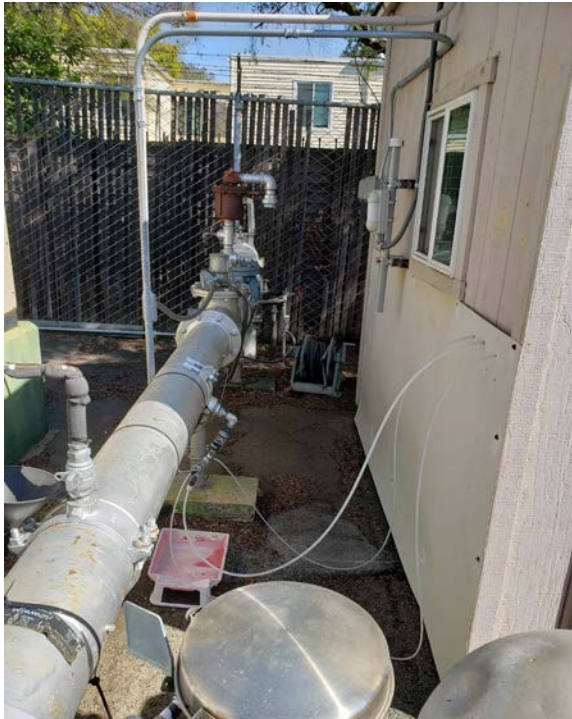
Well #8

- Paint tray used to catch chemical leak.

COMPLETED

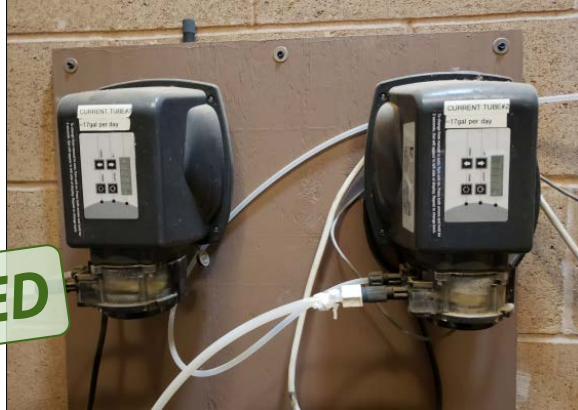
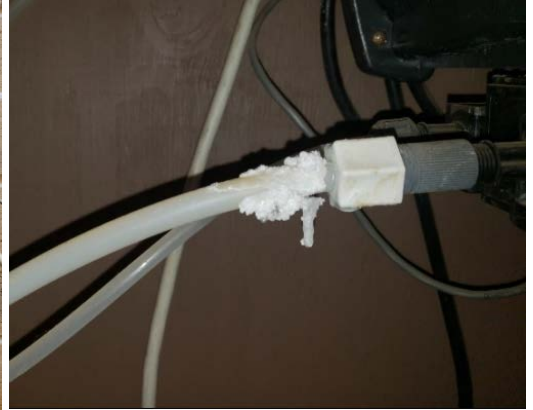
Well #9

- Chemical pumps have leaks and has build up.

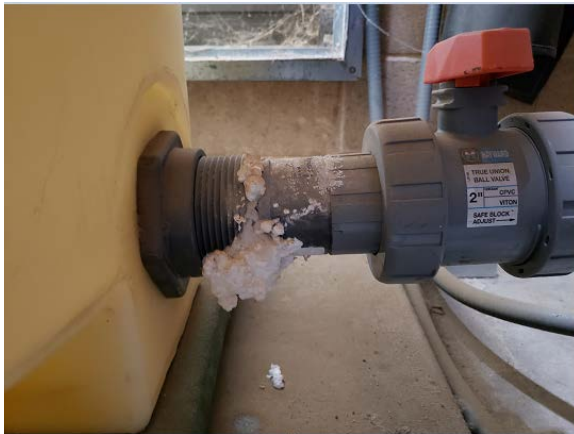
- The double containment tank is compromised by placing drain valves at bottom of tank through both walls. Leaks turned into build up on tank appurtenances. If the valve is breaks off, the tank contents will empty, defeating the double containment requirement.

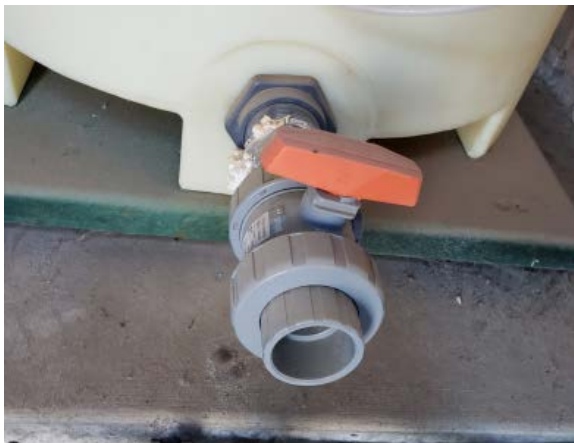
- Sodium Hypochlorite Tank will drain if ball valve opens, fails, or breaks off.

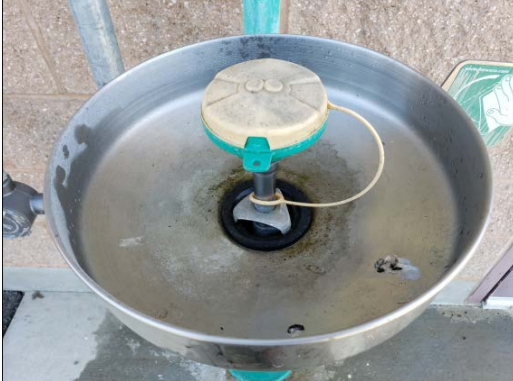
- Eyewash station bowl assembled incorrectly. The rubber gasket goes below the bowl and currently dams up the water from draining causing algae build up in the bowl.

COMPLETED

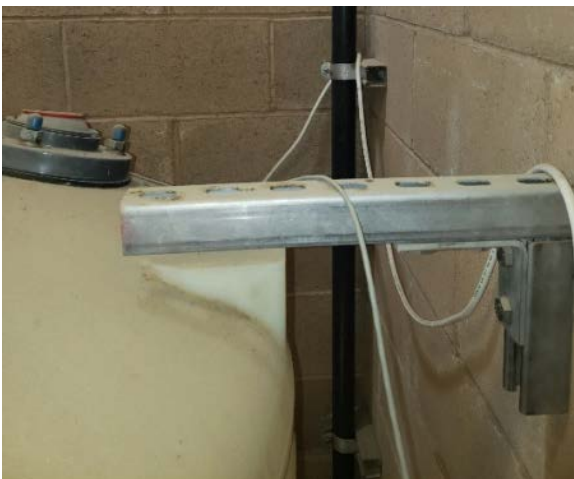
- Overhead hazards at eye level.

COMPLETED

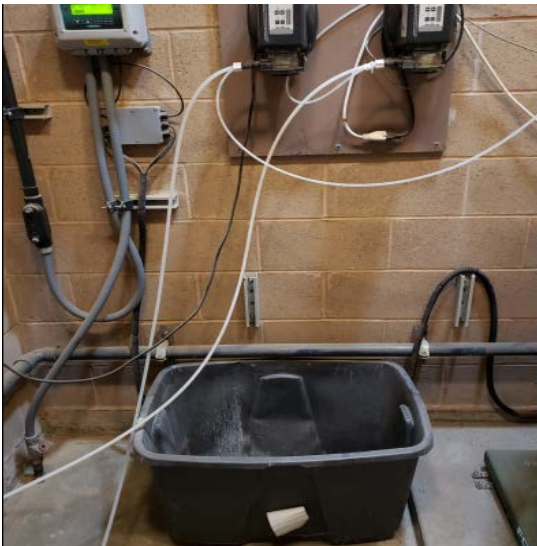
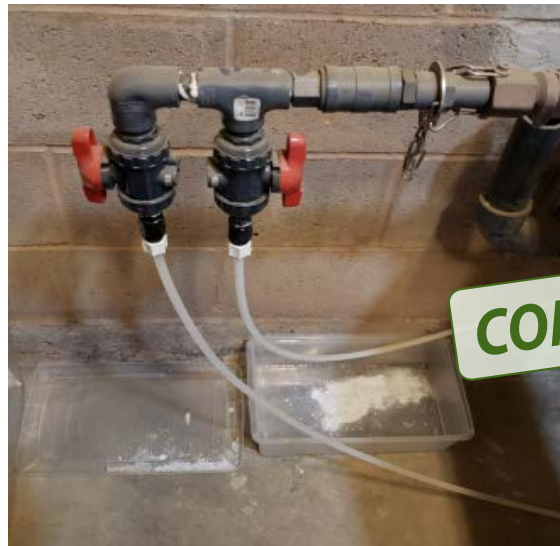
- Instead of double containment, tubs and lids that are placed to catch drips.

COMPLETED

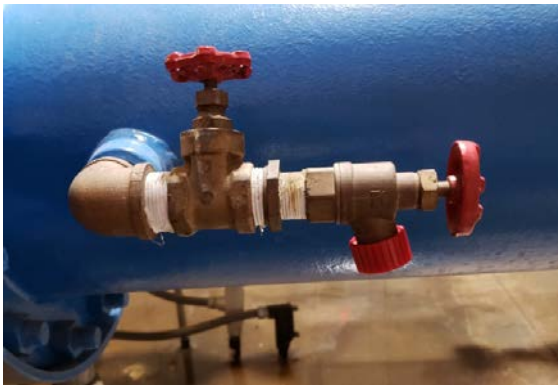
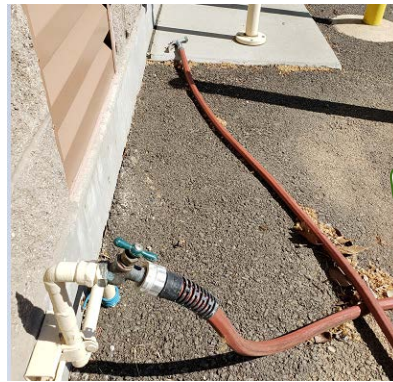
- All hose faucets are missing hose connection vacuum breakers. Some faucets have caps that are easily removed. DDW typically requires this if identified during an inspection.

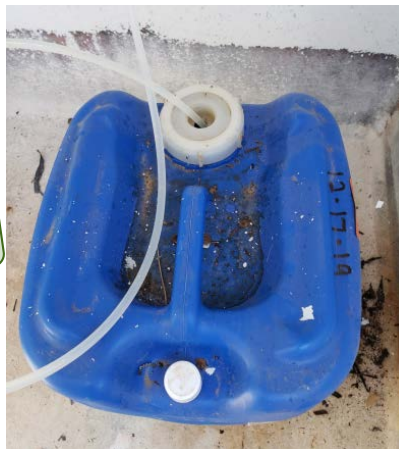
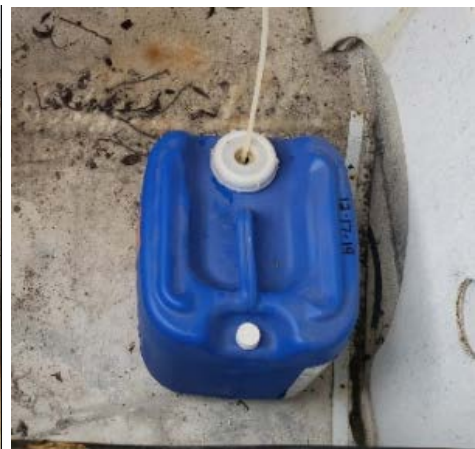
- The sodium hypochlorite degrades and creates disinfectant byproducts. The photos are a 5-gallon container from two facilities that remains full and are dated 12/17/2019 (over 100 days old). SSWD staff have found that 30 to 90 days, depending on conditions, is the chemical's useful life. Also, there is not a seal where feed line enters into container, which allows bugs, etc. to potentially enter liquid.

COMPLETED

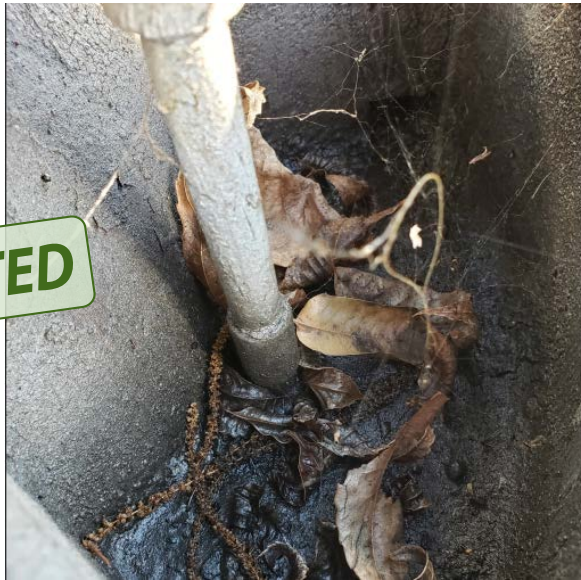
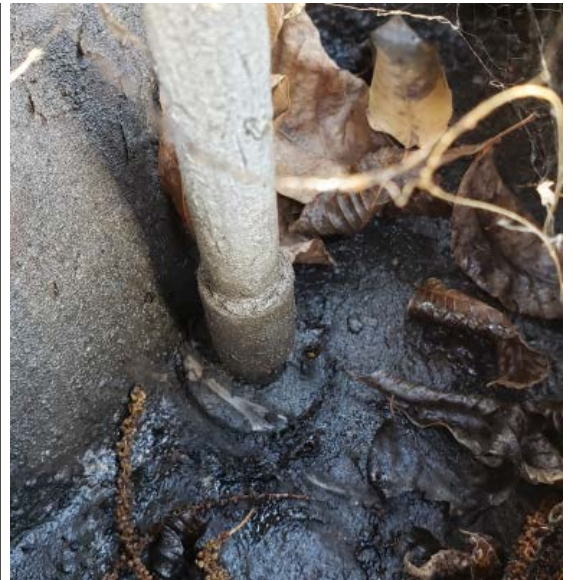
Well #2

- The sanitary conditions of the pump bases are in a state of severe neglect. The base of the pipe entering the pump base has a seal that is no longer secure or sealed. When the well turns off, contaminants from this area has the potential to be sucked into the aquifer.

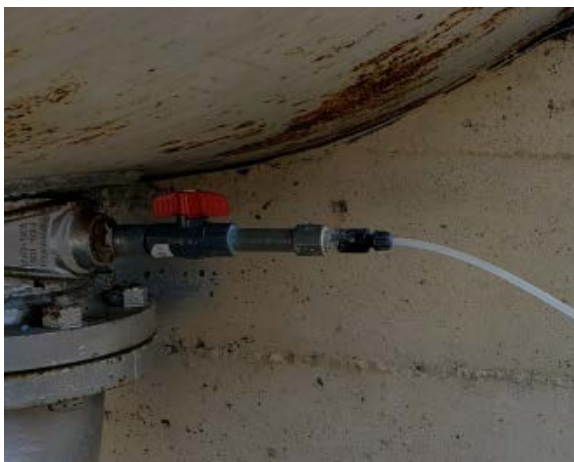
- Chemical injection was isolated (off) at the injection assembly. SSWD staff went to restore the chemical injection into service and found the assembly broken in multiple locations. SSWD made immediate repairs. Well #2 has history of raw water Bac-T positive samples and DDW allowed DPMWD to keep it in service only if continuously chlorinated.

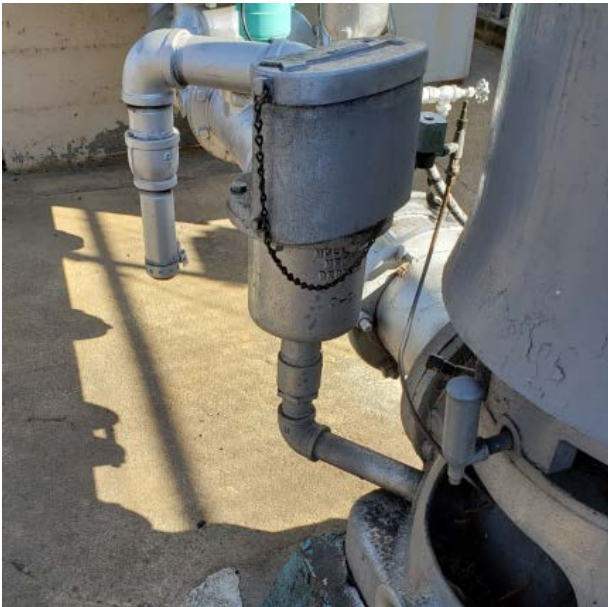
- The pump base Air Release Valve (ARV) discharge does not meet the minimum required 36" from ground surface. Reference: *Water Well Standards (Bulletins 74-81 & 74-91) – Section 10, Surface Construction Features.*

COMPLETED

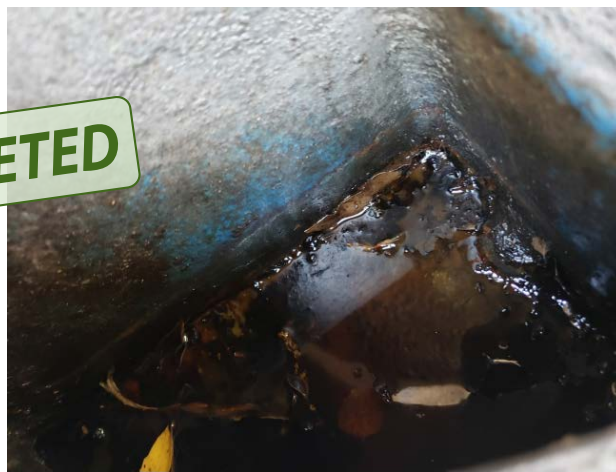
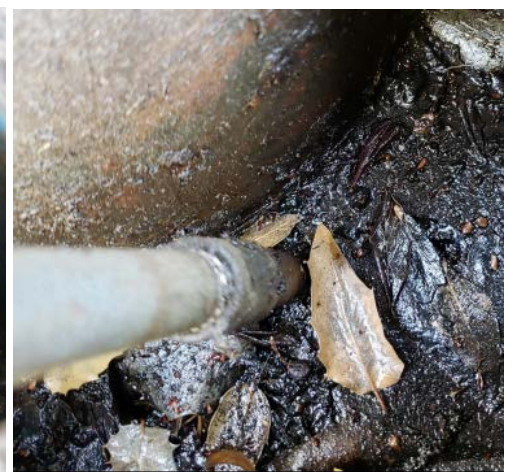
Well #4

- The sanitary conditions of the pump bases are in a state of severe neglect. The base of the pipe entering the pump base has a seal that is no longer secured or sealed. When the well turns off, contaminants from this area can potentially be sucked into the aquifer. Fortunately, the holes that allow the chambers of the pump base to drain into each other are clogged.

COMPLETED

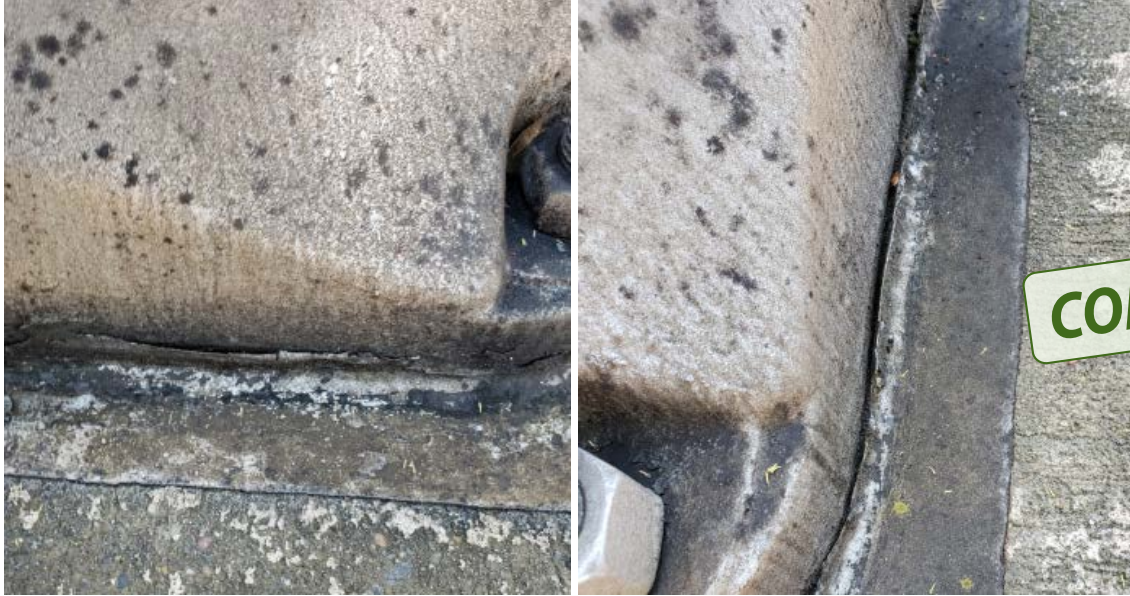
- Pump base seal is separating. When the well turns off, contaminants could potentially be sucked into the aquifer.

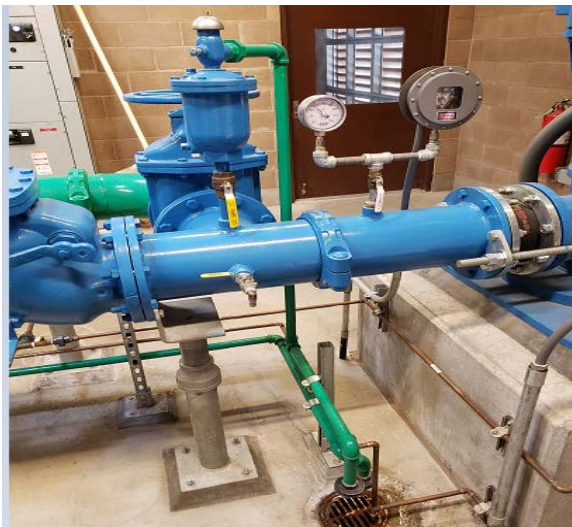
Well #6B

- ARV vent screens are not a minimum of 36" above ground surface. Installed pursuant to American Water Works Association Standard C512-04 and Manual M51 (2001)

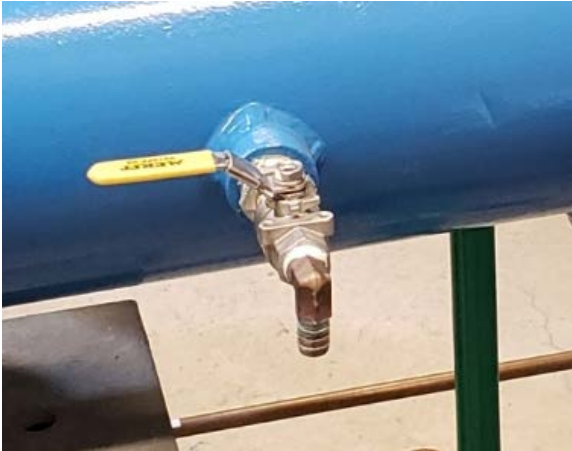
- Raw water sample ports are not threaded, but they are barbed. Required by DDW based upon *Chapter 16 – California Waterworks Standards - Article 3 - Water Sources §64560*

COMPLETED

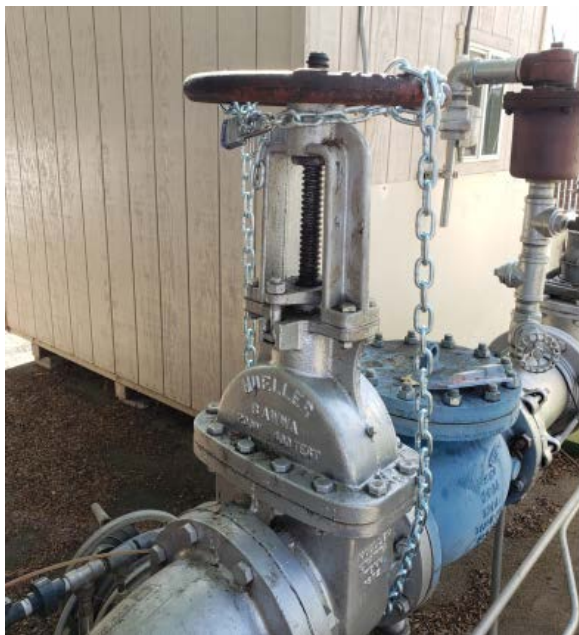
Well #8

- Motor oil was used for dripper oil causing the well to be placed in off position. SSWD staff secured the discharge piping valve with chain and lock to physically isolate the well from the distribution system.

COMPLETED

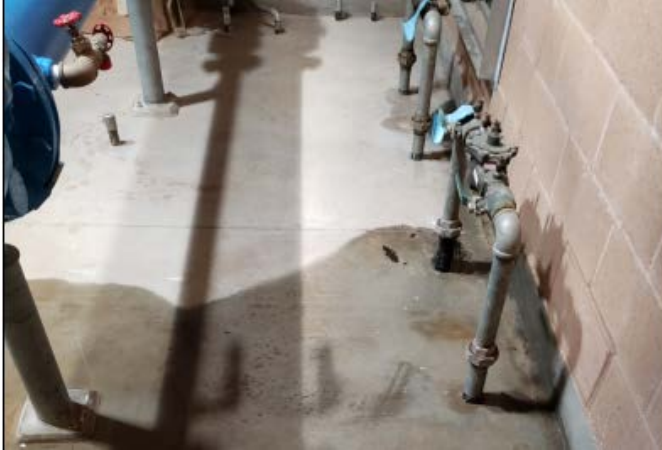
Well #9

- Backflow prevention device failures

COMPLETED
