Agenda

Sacramento Suburban Water District/Del Paso Manor Water District 2x2 Ad Hoc Committee

Subject: Safety Condition Assessment

DEL PASO MANOR WATER DISTRICT**Date of Visit: March 11, 2020****Advisor: Thor Benzing****RECOMMENDATIONS**

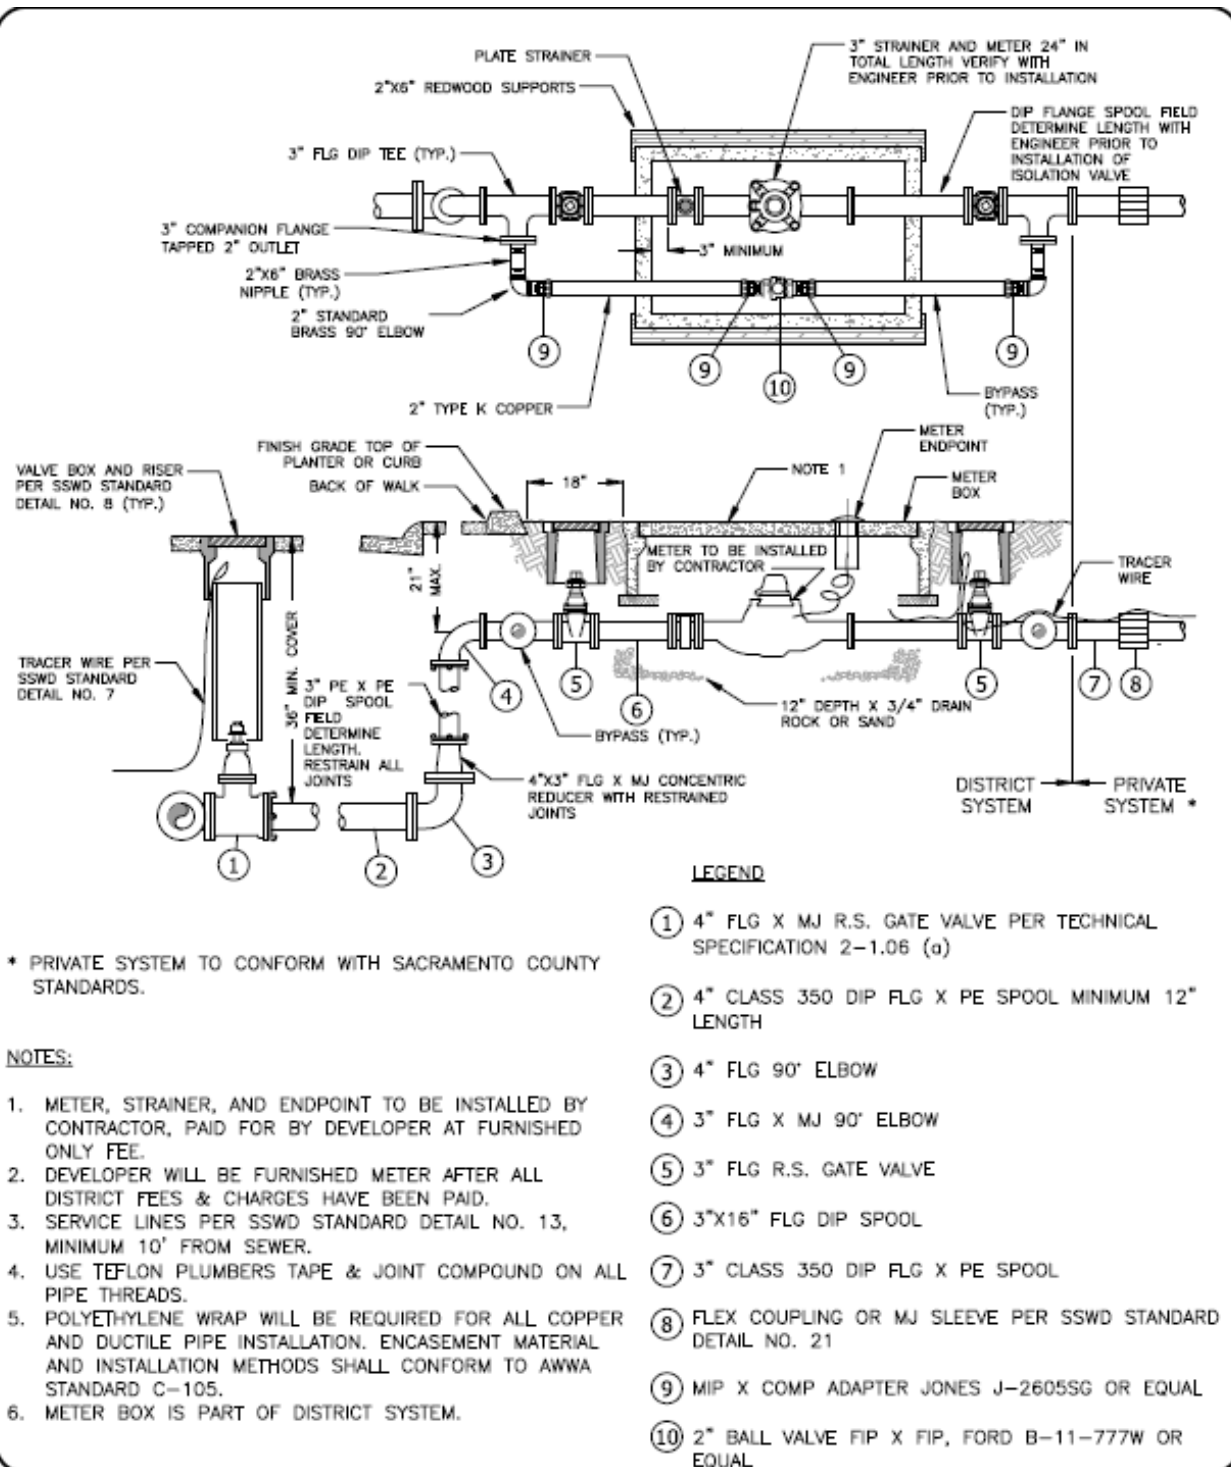
3-inch turbine meter

- Remove the meter from the backflow assembly and install the meter assembly as per SSWD Standard Detail No. 16 (Attachment 4), which is consistent with AWWA standards.
- Replace the current turbine meter with an AMI compatible 3-inch compound meter. 3-inch compound meters are accurate down to ½ gpm.
- Test the meter on a 3-5 year cycle depending on annual usage.
